THESIS

**ANALYSIS OF UNDERBEAD CRACKING IN
UNDERWATER WET WELDMENTS ON A516 GRADE 70
STEEL**

September 1998

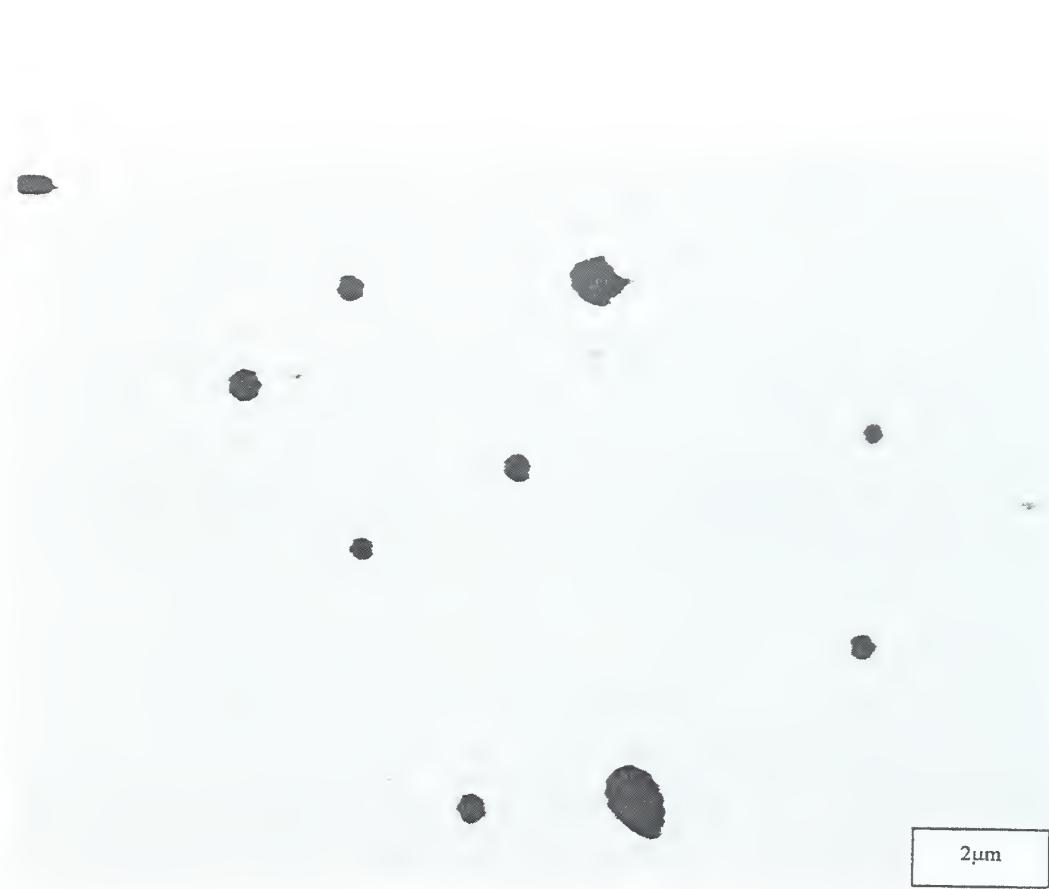
Figure 3.1 SEM micrograph of typical inclusion field in UWW05

The mean size, standard deviation and volume fraction was determined for the inclusions present in each of the fifty fields analyzed in each sample. The typical inclusion field shown in Figure 3.1 would by analyzed by counting, sizing, and identifying each inclusion through the use of the EDX. The results were then tabulated in a spreadsheet for calculation of mean size and number, standard deviation, and confidence. This data is shown in Tables 4.1 – 4.3.

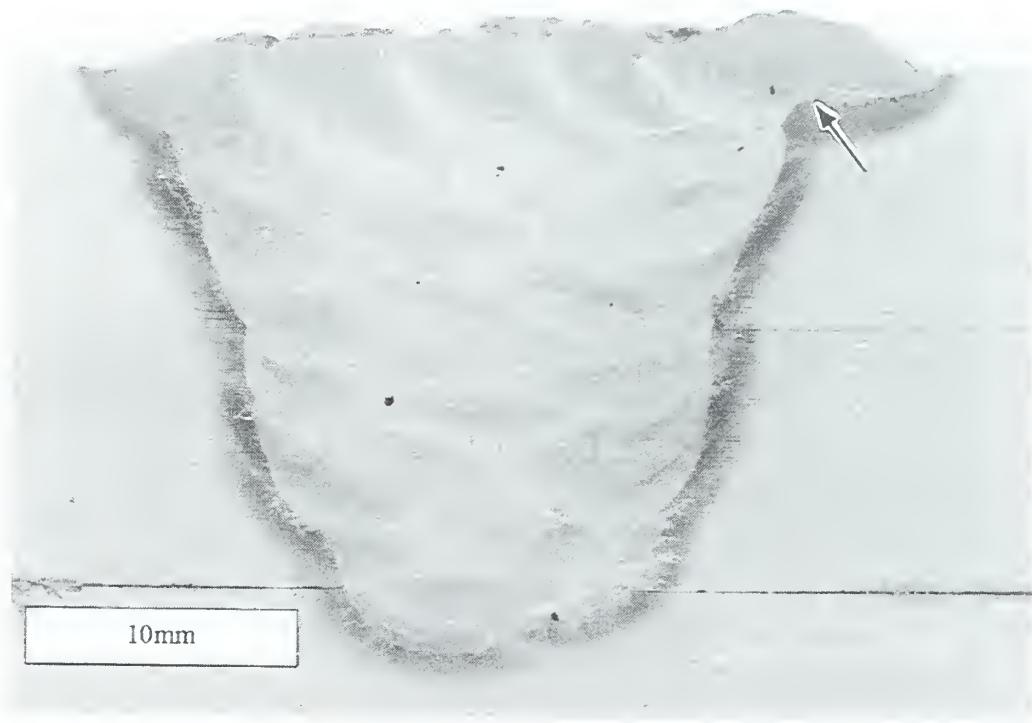
Figure 3.2 Macrophotograph of UWW05 weld sample – Underbead cracks are indicated by arrows

Figure 3.3 Macrophotograph of UWW12 weld sample – Underbead cracking is indicated by an arrow

Figure 3.4 Macrophotograph of UWW25 weld sample – Underbead cracks cannot be seen at this magnification

The macroscopic photographs taken by GRM Photo, Inc. that appear as Figures 3.2 -3.4 show various features of the weld samples. At this magnification extensive cracking from the weld cap to the root is seen on the UWW05 sample whereas the cracks in the UWW12 and UWW25 are somewhat localized near the cap of the last weld pass and are much finer. The additional feature that can be seen because of the deep etching is the effects of the multipass weld as described by Lundin, et al., [Ref. 3] and seen in Figure 2.4. Bead tempering is evident in all of the passes except the last one. This suggests a reason why the cracks are likely to originate near the last weld pass because this area of the weld sample has the highest hardness which was confirmed by microhardness measurements.

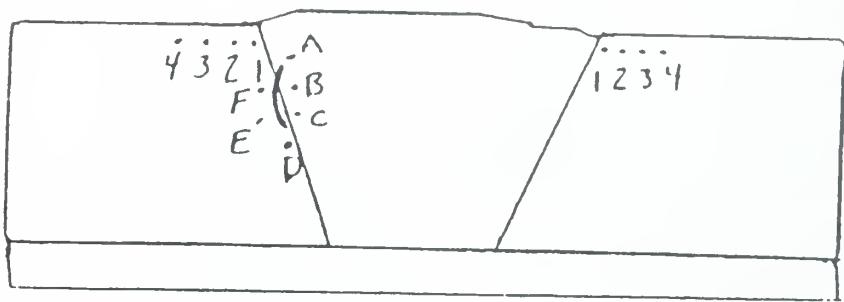
The microhardness measurements described in the experimental procedure section are listed in Table 4.4. Figure 4.4 shows the typical regions where microhardness measurements were taken. With an average hardness of 296-297 HV in the HAZ near the last pass weld cap area, this is an indication that the microstructure is martensite and bainite as was confirmed by optical microscopy. The average hardness around the cracks found near the last pass of the weld was between 360 and 366 HV. This indicates that the microstructure is nearly all martensite and explains the reason that cracking occurred in this hard and brittle section of the HAZ.

Figure 4.4 Typical regions where microhardness readings were taken

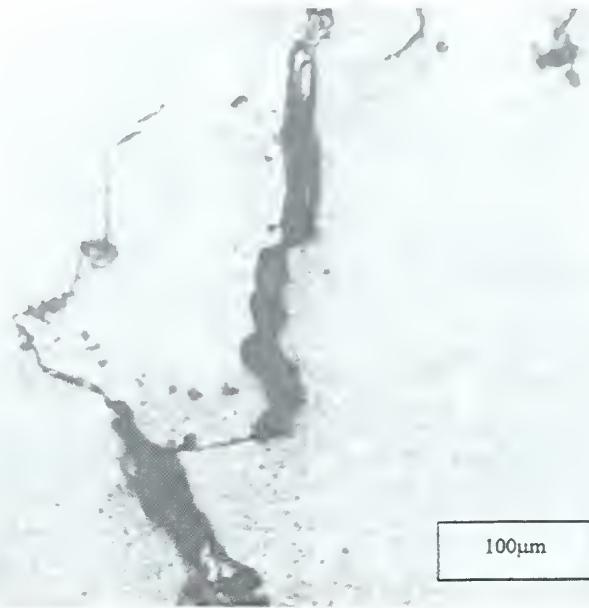
microstructure in which the cracks were found. The cracks nearly always were found in the coarse grain region of the HAZ near the fusion line. The cracks would eventually be arrested after branching into the base metal or into the fine grain region of the HAZ. The extensive crack branching found in UWW05 is shown in the micrographs in Figures 4.5 and 4.6. Note the microstructure in this region is essentially martensite and bainite. In addition, the microstructure of the weld metal was also analyzed to confirm the findings of Fox et al and Murray et al [Ref. 8, 9]. The weld metal microstructure was found to consist mostly of acicular ferrite with smaller amounts of Widmanstatten (side plate) ferrite, grain boundary ferrite, martensite and bainite.

Figure 4.5 Optical micrograph of UWW05 showing extensive crack branching

Figure 4.6 Optical micrograph of UWW05 showing martensite microstructure surrounding crack

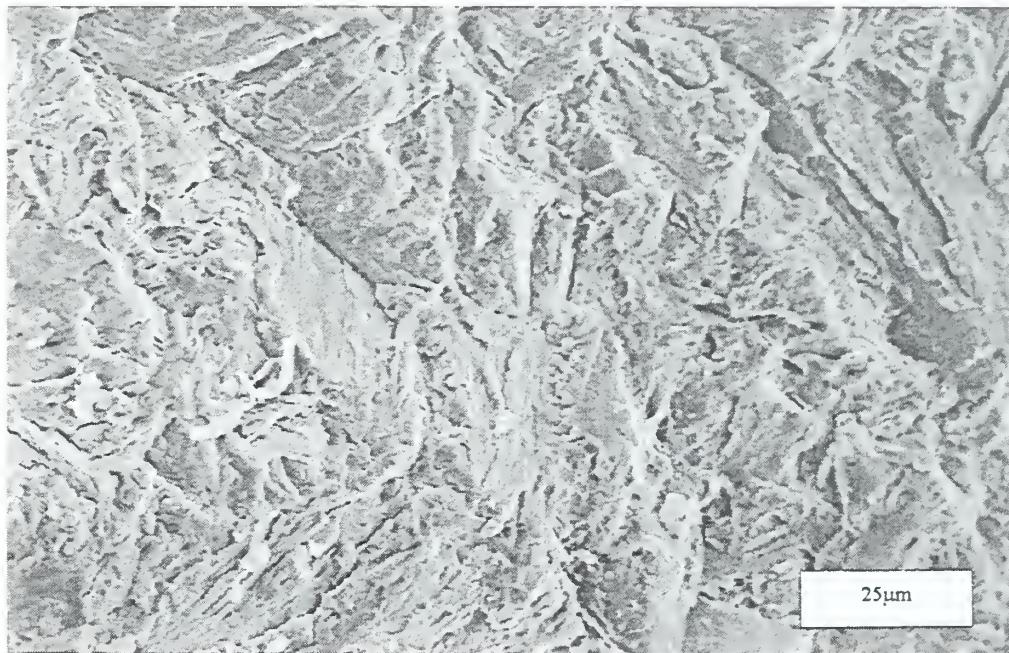
Underbead crack surfaces of UWW05 were examined in the S200 SEM to determine the mechanism of failure. Transgranular cracking and secondary cracking perpendicular to the fracture surface were clearly seen in this sample. Figure 4.7 is a micrograph which clearly shows these features which are typical of hydrogen assisted cracking.

Figure 4.7 SEM micrograph of transgranular cracking on the surface of the fracture with secondary cracking
